## Powder Coating ZS Carburetors

by Nelson Riedel  
Initial 12-21-01

The carbs for my '76 TR6 were overhauled last winter. Before the carbs were installed I got interested in powder coating and put together a power coating setup. (There are notes on this website describing both the carb overhaul and the powder coating equipment.) I decided to powder coat the carbs after observing how great the powder coated clutch master cylinder looked in comparison to the stained appearance of the carbs. Before jumping in and screwing up my good set of carbs it was decided to do a test run on an old carb. It went pretty well. The major problem was a few bubbles probably caused by out gassing from the castings when they were heated. This showed up most on the bypass valve castings. This was avoided on the real carbs by baking the castings before doing the cleanup.

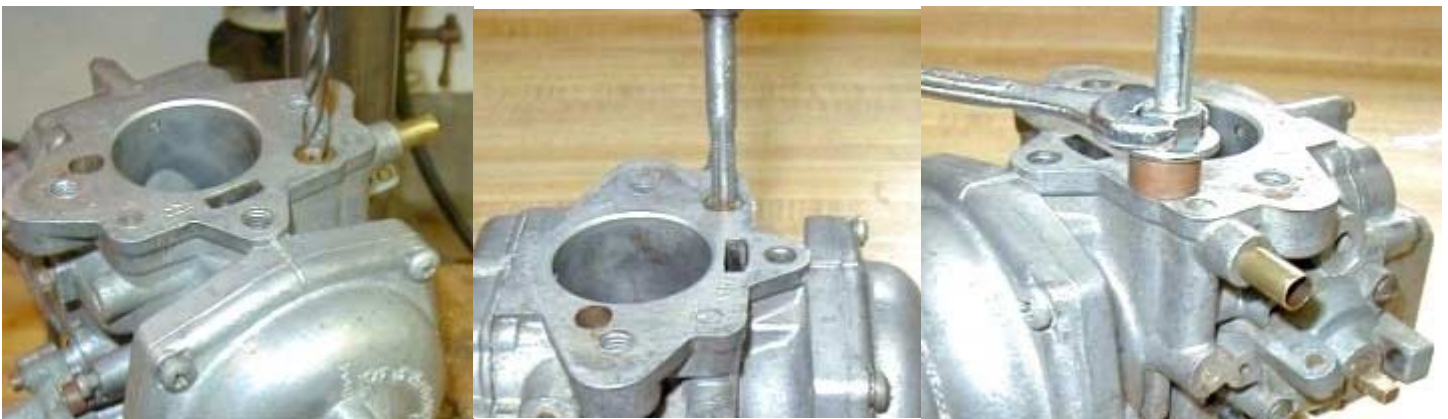
Because complete disassembly is required it was decided to do one carb at a time so the other carb could serve as a model as to where everything goes. The first challenge was to deal with the float chamber vent valve provided on '73 and later carbs described in Part II of the carb overhaul notes. It is impossible to seal the passages well enough to keep the small beads out of the valve and the valve won't operate properly if there are any beads in it. (I know this from experience because I blasted the trial carb without removing the valve and plugged everything up). I hadn't seen any documentation on how the valve operated or how to disassemble it. My guess was that the brass sleeve was pressed into the carb body so the first step was to press the sleeve out. Unfortunately there is no access to the back side of the sleeve to press it out. The technique used to remove the sleeve was to enlarge the sleeve ID with a 17/64 inch drill to a depth of about 1/4 inch and then thread the sleeve 5/16-TPI deep enough so that a bolt can be screwed in about 3 turns. The taps are tapered so a little torque is required to get the last couple turns on the bolt. The bolt was then removed and a nut, washer and spacer placed on the end of the bolt and the bolt was then screwed back in. The nut was then tightened to draw out the sleeve. See photos below.

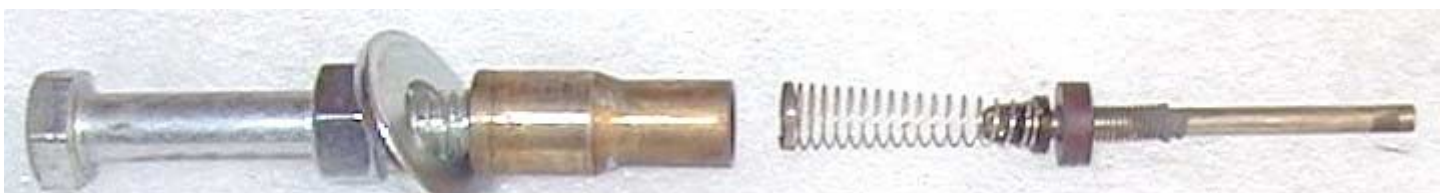
The next photo shows the sleeve and valve components.

The first thing assembled was the float chamber vent valve; the valve with the little springs was slipped into position and the brass sleeve pressed home. The rest of the carb was then reassembled, reinstalled and tuned as described in the carb overhaul notes.

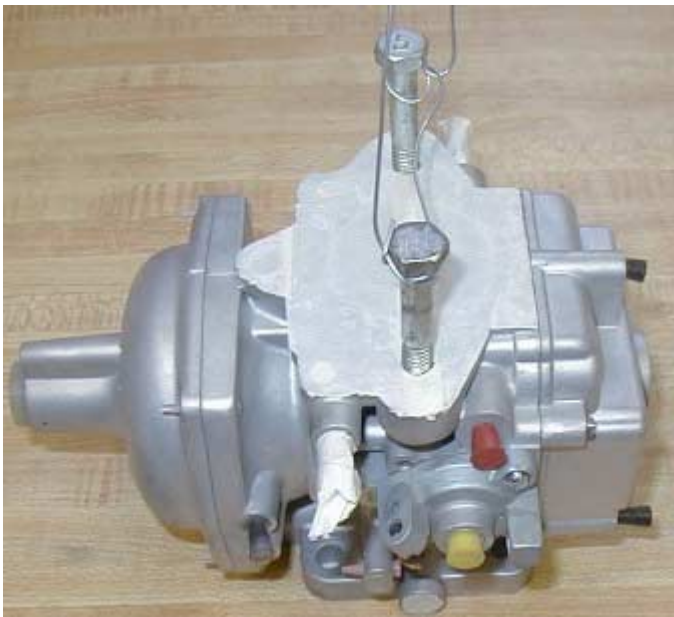
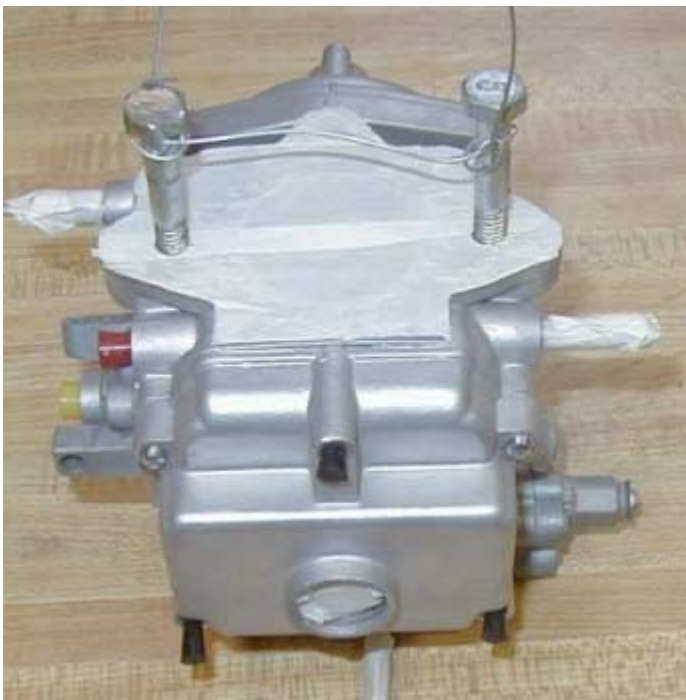
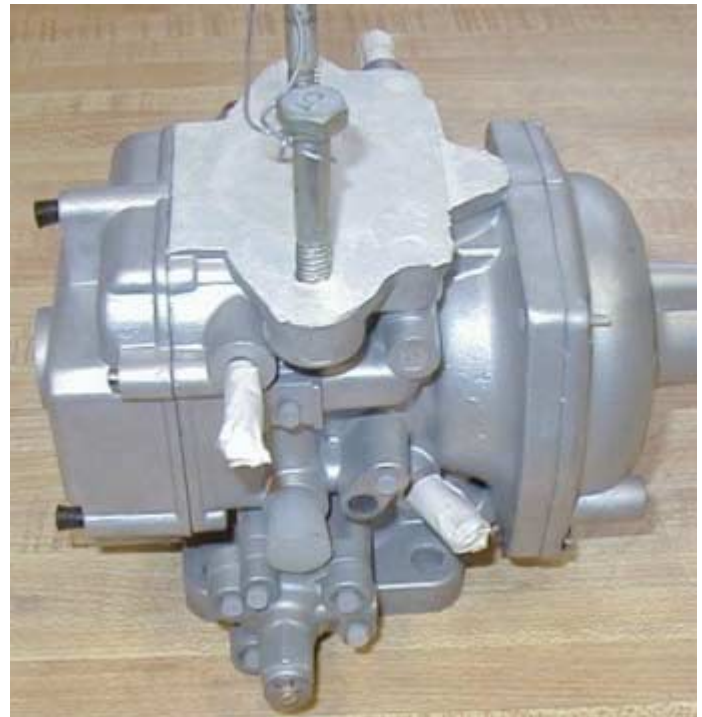
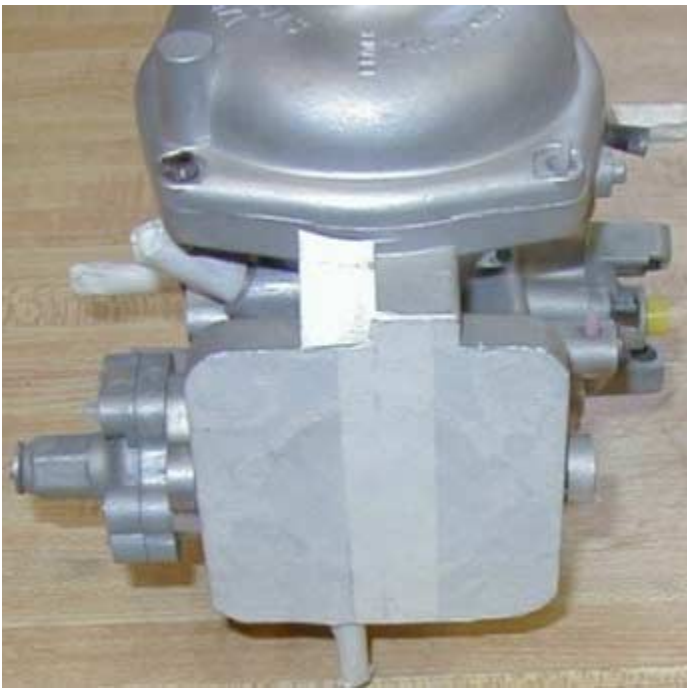
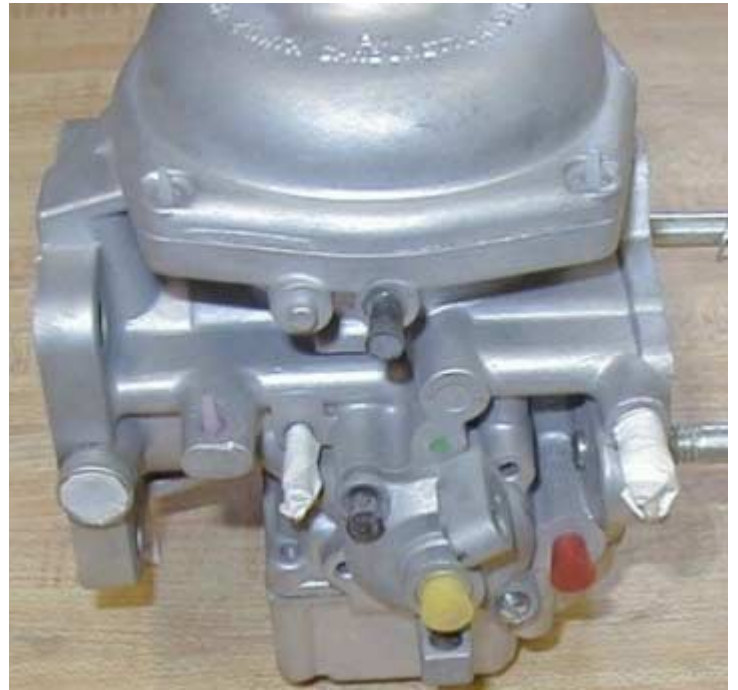
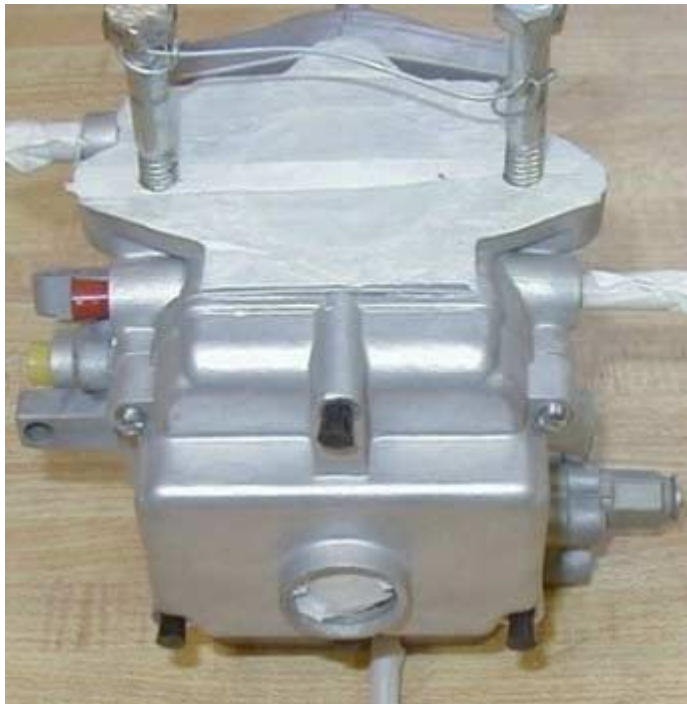
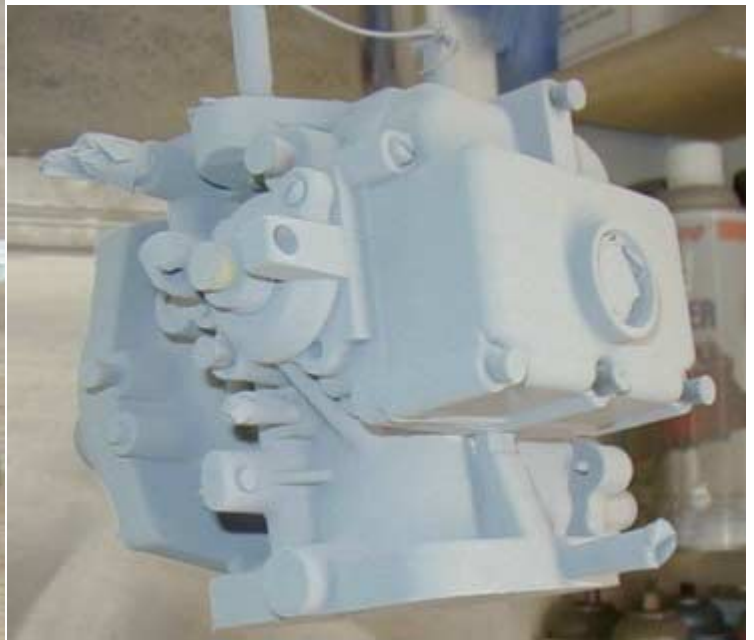
The last photo on the right above shows the carb after powder coating and before curing. The temperature compensator (everything masked except visible exterior) and vent lever castings were also powder coated and cured at the same time as the main castings.

These parts were attached using one round head screw per part. The regular screws were not used. The attachment of these parts served to cover and protect the mating surfaces from the blasting and painting. Next, the very small vacuum ports adjacent to the manifold were plugged and covered with duct tape to keep the glass beads out of the small chambers. Plugs were inserted in the throttle bushes and a rag was stuffed into the main carb passage. The unit was then bead blasted until shiny bright over the entire exterior surfaces. The inside and plug portion of the temperature casting was covered with tape and also blasted. The vent lever was also blasted separately.

After the blasting, the castings were separated and washed in metal prep and then rinsed in clear water and blown dry. The small castings were then reattached to the main body using the one screw per part. The surfaces that mate with the manifold and air filter were then masked as were all brass tubes and the vent lever shaft ('73 & later). All ports and screw holes were then plugged with silicone plugs. The photos below shows the masked carb. The 5/16 inch bolts with wire between were used to suspend the carb while powder coating and curing.

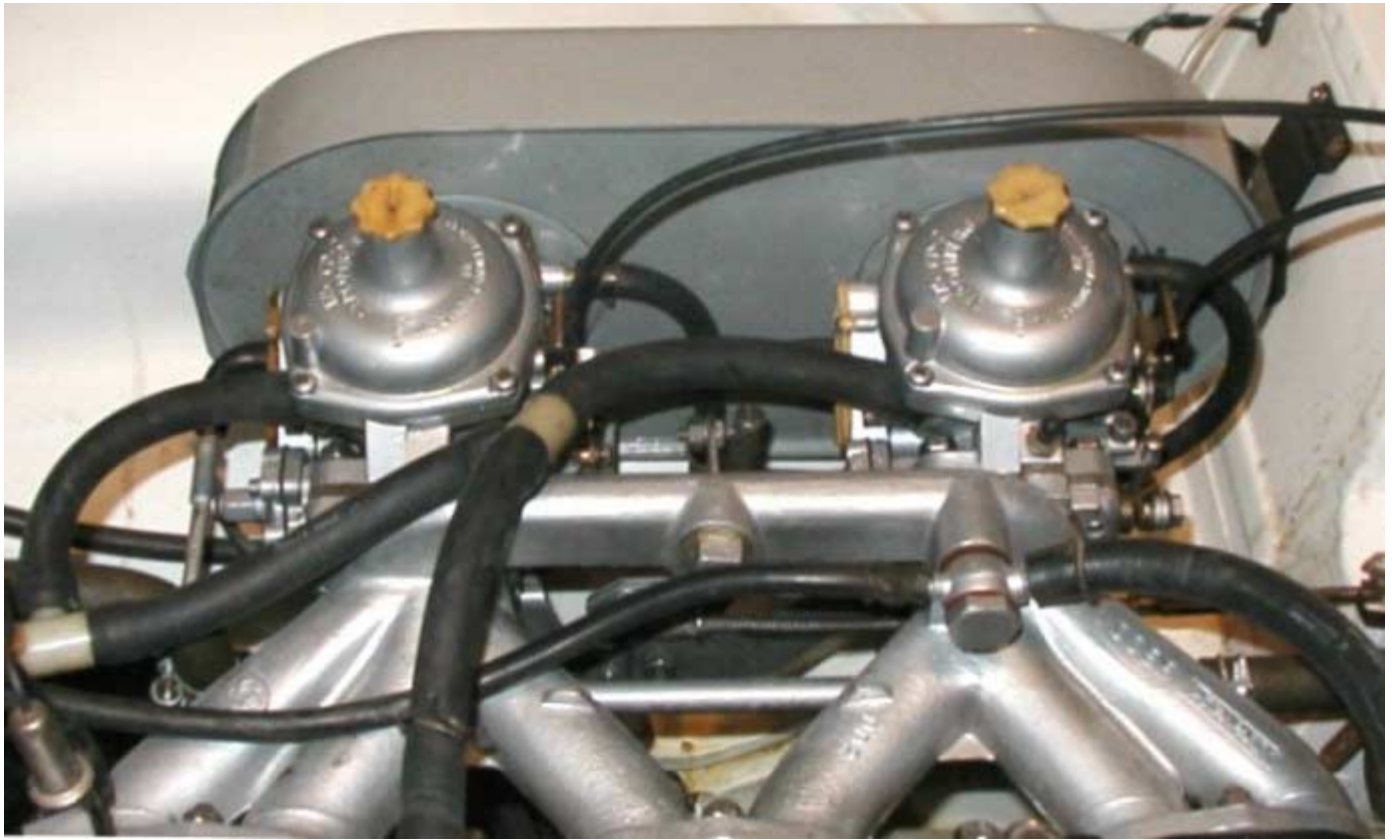
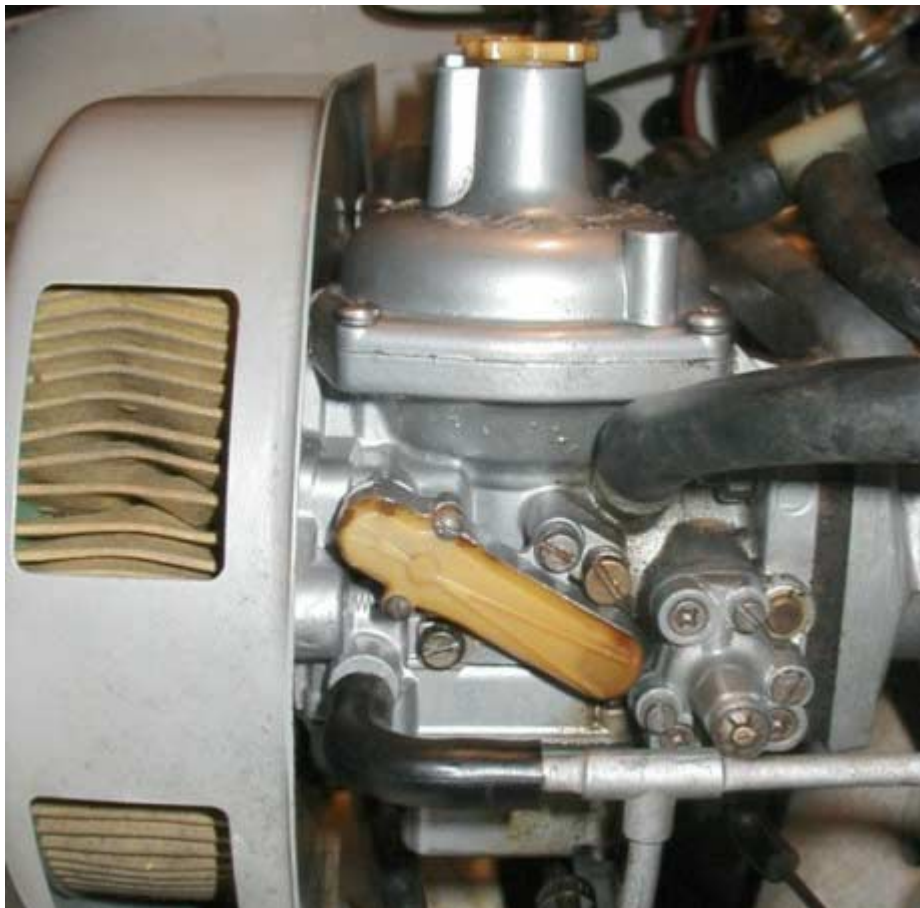
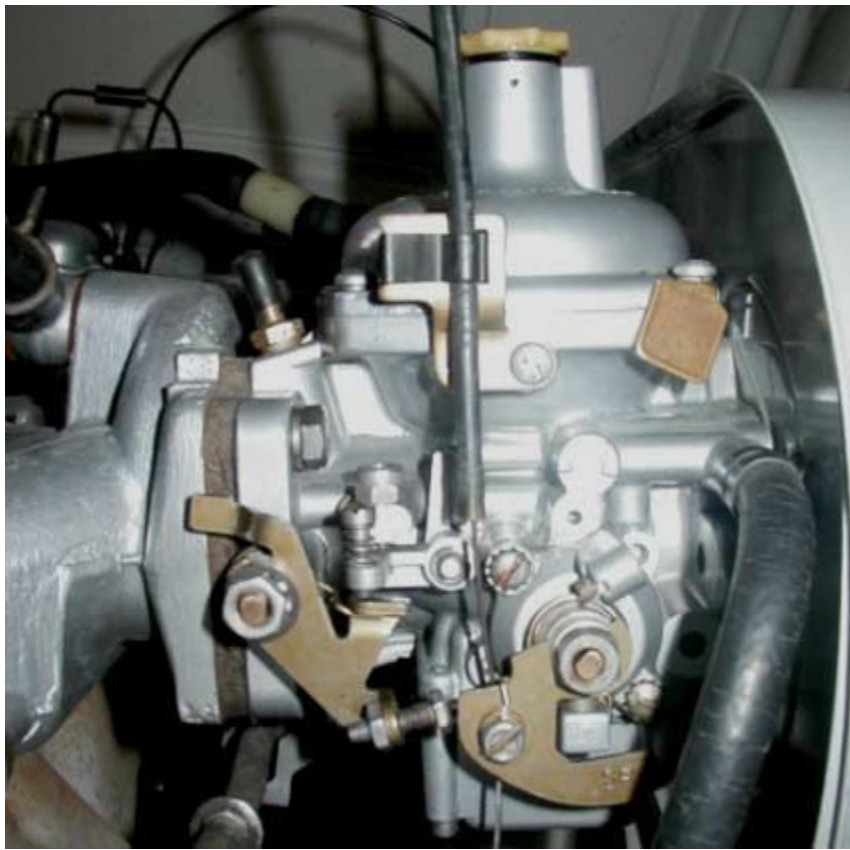
The photos below show the finished carbs installed on my '76 TR6.
